The Aspendos Aqueduct and the Roman-Seljuk Bridge Across the Eurymedon

Paul KESSENER-Susanna PIRAS*

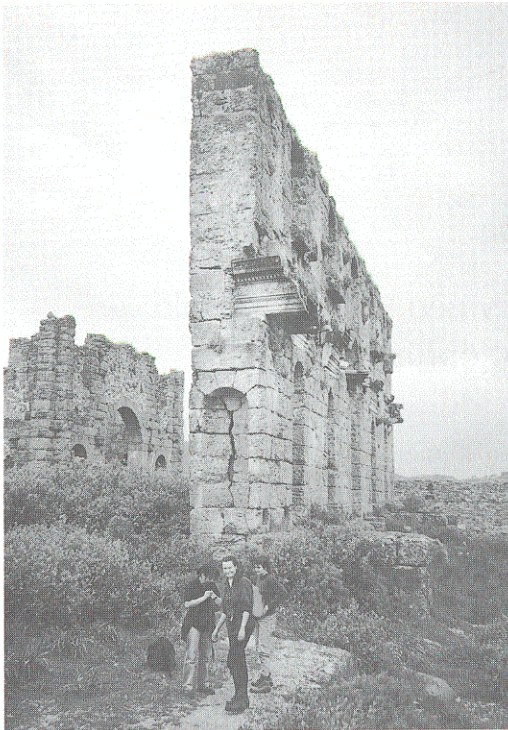
Figure 1
The Aspendos nymphaeum seen from the west.
To the left: the entrance hall of the basilica.

occupies an oval, flat-topped hill with steep slopes on all sides rising about 30 m above the surrounding plain³. As seen from a distance, the skyline of Aspendos is dominated by the remains of the Nymphaeum (2nd-3rd century A.D.) and by the monumental entrance hall of the Basilica, both rising to a height of 15 m. (Fig. 1).

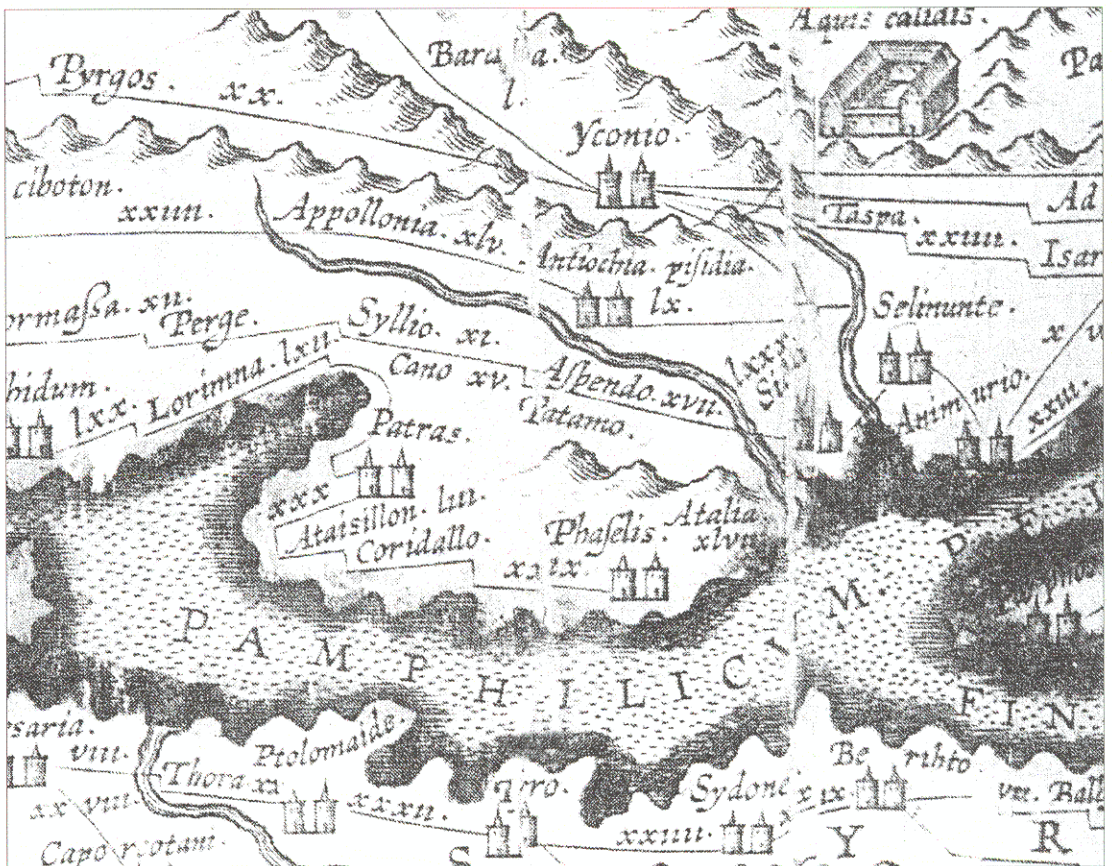
Figure 3
Seljuk bridge over the Eurymedon
(P. Kessener-S. Piras,
S. Harmeling-M. Stitz).

The Seljuk Sultan Gıyaseddin Keyhüsrev I from Konya conquered Pamphylia in 1207. During Seljuk rule the present bridge over the Eurymedon 2 km south of Aspendos was constructed. Until a few years ago this bridge was used by local traffic and it is frequented by tourists today. The 5 m wide bridge crosses the river by means of 5 arches, with an additional two arches on the left bank for flooding conditions, but not in a rectilinear course but with a remarkable parallel shift in the middle of the river giving it a zigzag plan (Fig. 3). This feature is commonly explained to the visitor as a deliberate device introduced by the builders of the bridge to provide a better defence. On closer inspection, the true reason for this remarkable design quickly becomes clear. The foundations of several piers and of the ramp on the left side of the river are of Roman origin. Moreover, a ramp-like Roman construction on the right river bank equipped with one partly intact arch and standing isolated today, also indicates the existence of an earlier crossing, of larger dimensions (Fig. 4). Clearly the ruins of the Roman bridge have been used by the Seljuks as the foundation for their new construction. The Roman bridge had been about twice as wide as the present one and the Seljuk builders were able to include its stable remains within their design. However, of the foundations of the Roman piers, only the upstream half had remained in a satisfactory condition, while annoyingly just the downstream half of the

adjoining pier had been preserved. By making use of these Roman remains the Seljuk architects were able to design the present bridge, its zigzag plan representing the reuse of this Roman material. They knowingly accepted this unusual course for their bridge because of these constructional reasons, leaving us with a picturesque example of their practicality to be admired today.

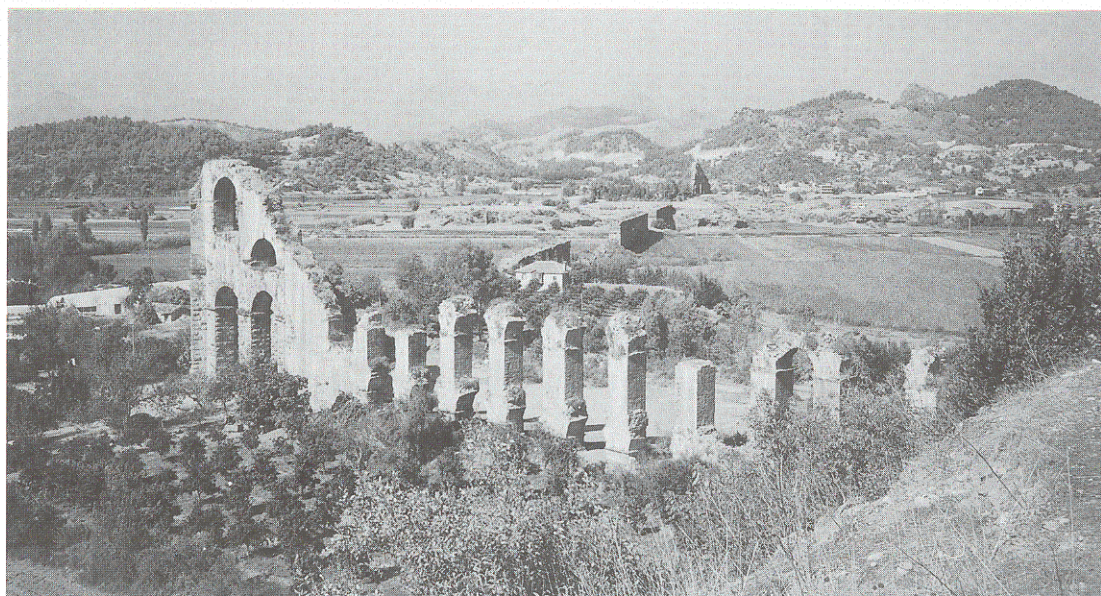
Figure 6
The Aspendos siphon,
view from the acropolis
(H. Franssen).

having a channel of modest dimensions, 55-60 cm wide and 90 cm high on the inside⁹. The water crossed the 1.7 km wide valley, between the mountains to the north and the acropolis, by means of an inverted siphon (Fig. 6). The pipeline of this siphon was made from perforated stone blocks, and ran up and down over two 'hydraulic towers' presently about 30 m high and over the 510 m long bridge between these towers, before arriving at the northern edge of the city. It is assumed that the top of each tower was equipped with an open tank into which the water poured from the pipeline and from which the water entered the next section, dividing the pipeline into three consecutive siphons. The purpose of the hydraulic towers and the breaking up of the siphon into three is as yet not clearly known, although a relationship between these three consecutive siphons and the prevention of destructive water pressure conditions endangering the pipeline at the bends is plausible. During the 1996 campaign the siphon could be traced from header tank to receiving tank, from which it could be deduced that the towers were originally up to 40 m high. The towers are among the highest of Roman constructions, presumably at the top of the list stands the Pont du Gard measuring 48.77 m. The elements of the Aspendos siphon were extensively described in an earlier issue of this periodical¹⁰.

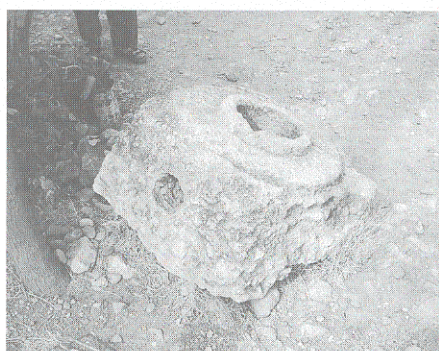
Figure 7
Stone pipe element
of the Aspendos siphon
(H. Franssen).

The pipe elements of the siphon measure 86 x 86 x 50 cm to 90 x 90 x 70 cm and have a perforation of 28 to 30 cm (Fig. 7). The stones were made of limestone cut at the foot of the Zincirli mountains, a small range of mountains which climbs to a height of 300 m above the acropolis and lies to the east, just across the Eurymedon. Because of the excellent view from this range, over the Aspendos acropolis and its surroundings, including the bridge over the Eurymedon, its most prominent peak, with a vertical east face of over 100 m, had served as fortified look out post. This is shown by the remains to be seen on this peak of fortification walls and of several buildings and cisterns (Fig. 8). At the foot of the mountain range, just outside Çakıs village not far from the east bank of the Eurymedon, a small limestone outcrop called "the hill with the windows" presumably served as a quarry for the pipe elements, the resulting cutout chambers were later reused as tombs for burial. These chambers were apparently destroyed early in 1998 for the production of cement or for some similar reason, a corner or two of some of the chambers is, regrettably, all that is left to be seen of this structure.

The pipe elements were joined together by means of a socket and flange system and sealed off by a mixture of lime and olive oil¹¹. This material expands and hardens when in contact with water to withstand considerable water pressure, which in the Aspendos pipe line attained a pressure of up to 4 bar (40 m of water column). Of these stone pipe blocks one may still find a few lying about the course of the siphon, but originally the 1670 m long pipeline contained over 3000 of these elements. Once the water had arrived at the edge of the acropolis, it was carried by means of an open channel towards the richly decorated Nymphaeum, which stands today 15 m high and 35 m long and is to be found on the north side of the agora. The city was proud to have an aqueduct and it was not

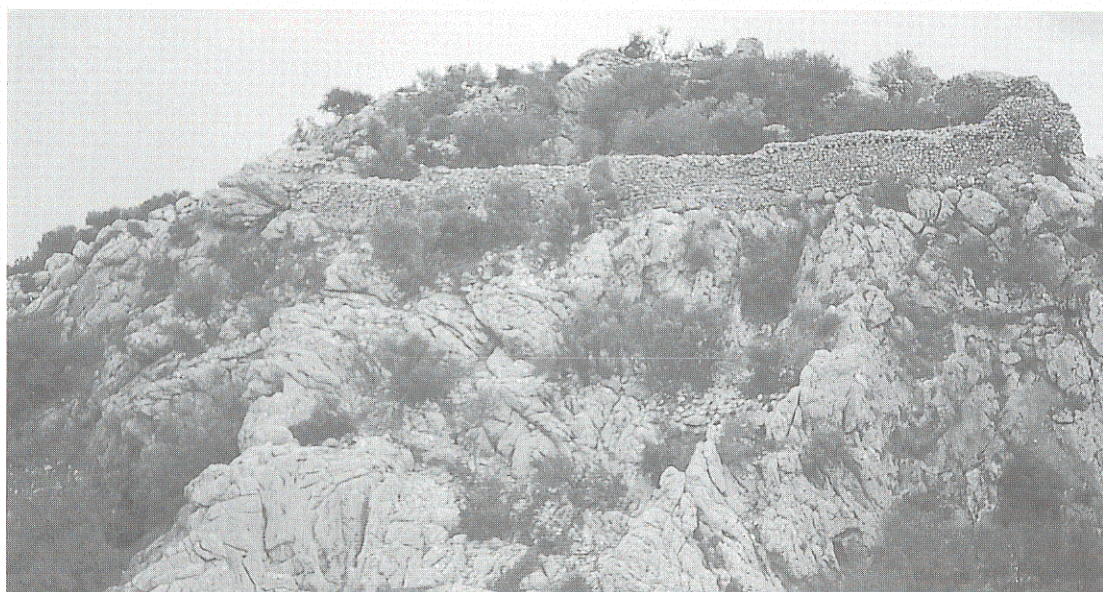
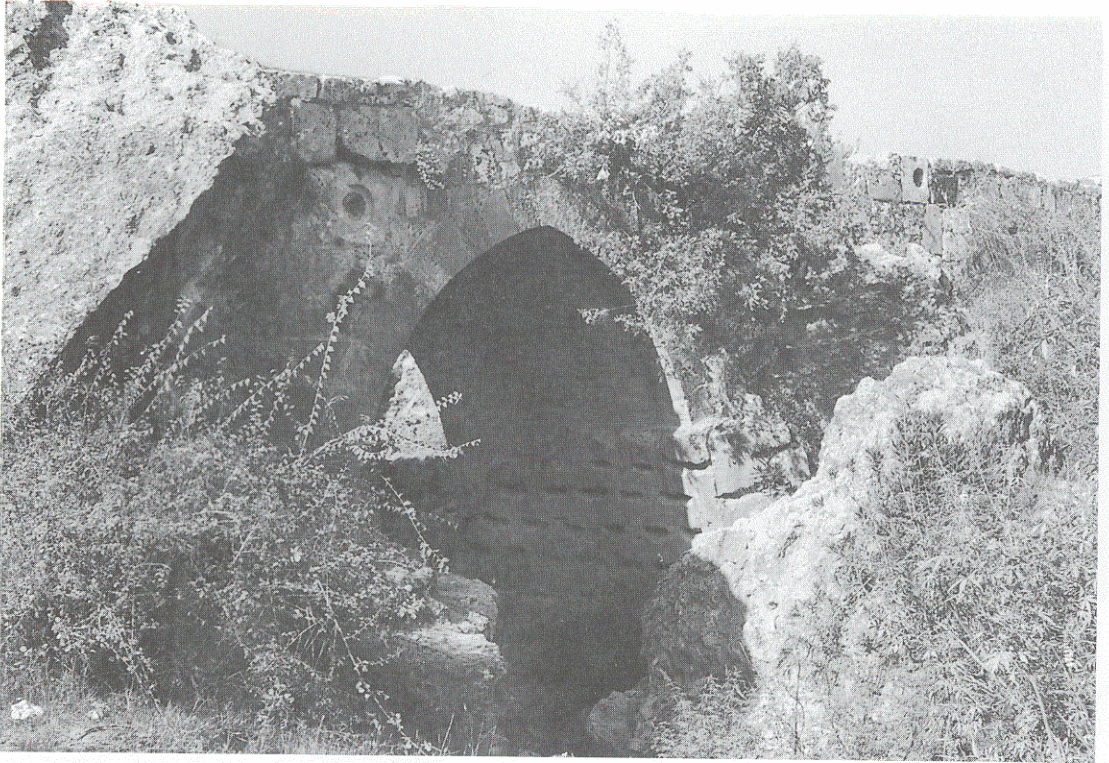
Figure 9-10 Pipe elements of the Aspendos siphon incorporated into the Seljuk bridge.

Turning our attention towards the Seljuk road bridge over the Eurymedon, we discovered that several perforated stone blocks, reused pipe elements of the Aspendos siphon, have been incorporated into the walls of the bridge. It is often pointed out that the Seljuks used the remnants of the Aspendos siphon as *spolia* for the construction of their bridge (Fig. 9,10). In some of the perforations calcareous incrustations (sinter) indicate that water did flow through the pipe elements for a prolonged period of time. Underneath the smaller arches, on the eastside of the Seljuk bridge, at low water level, numerous pipe elements were seen lying in the riverbed. During the 1998 restoration works this part of the riverbed has been covered with a layer of concrete and these stones have now disappeared from view.

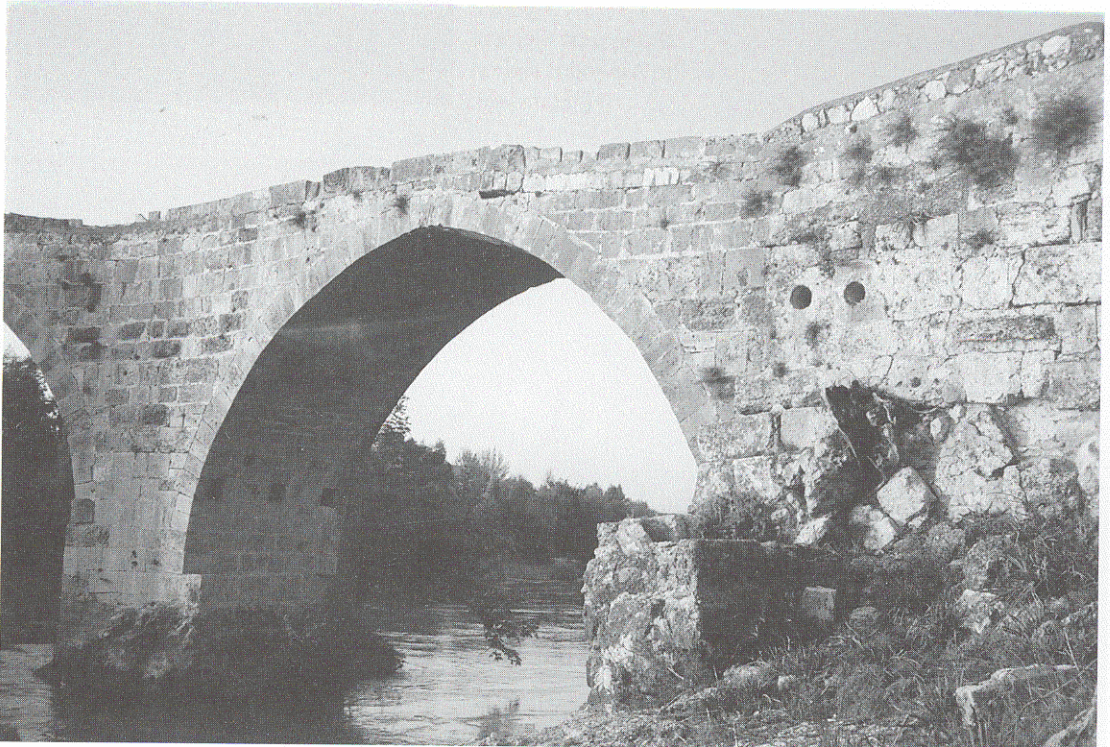
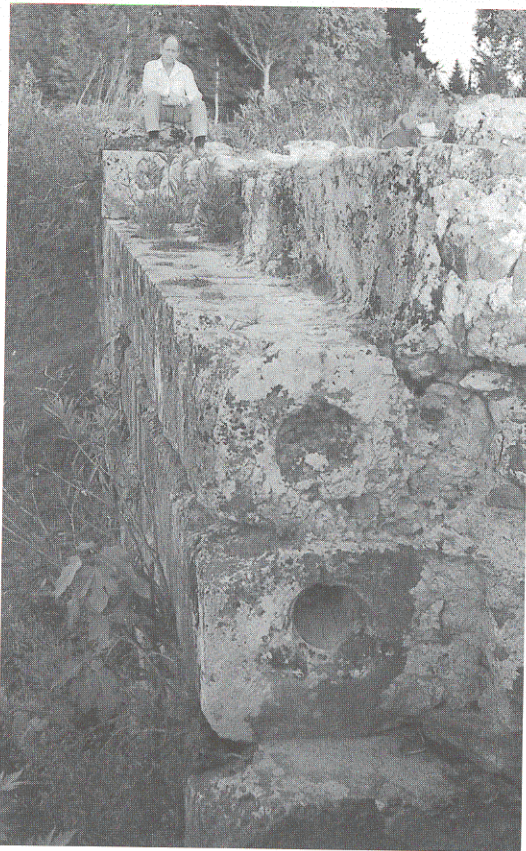
Figure 11
Pipe elements of the
Aspendos siphon
incorporated in the
Roman mole.

Surprisingly, on further inspection one may discover that a much larger number of these stone pipe elements are incorporated in the *Roman* moles on either side of the river (Fig. 11)¹². Furthermore, the largely intact Roman breakwater on the right side of the river, and the ruins upon which the piers of the sixth arch of the Seljuk bridge was constructed (counting from the right bank of the river) show that these pipe elements were used as construction material for the Roman bridge. During the 1996 campaign over 250 of these elements were counted incorporated in these Roman remains, while only 15 were seen incorporated in the fabric of the Seljuk bridge.

As the inside of the perforations of several stone blocks is covered by calcareous incrustations, these pipe elements were apparently reused for the construction of the Roman bridge after prolonged operation of the aqueduct. Thus the Roman bridge must have been built after the aqueduct and the siphon had gone out of use for some reason. This posed the question of the period of operation of the aqueduct. From the thickness of calcareous deposits (sinter) in the aqueduct channel found some 10 km north of Aspendos, it could be estimated that the water had run along the channel for at least about 130-150 years.

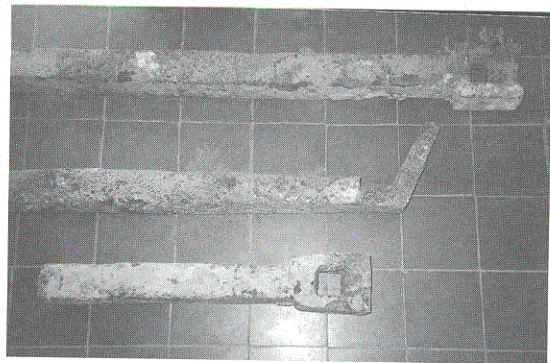
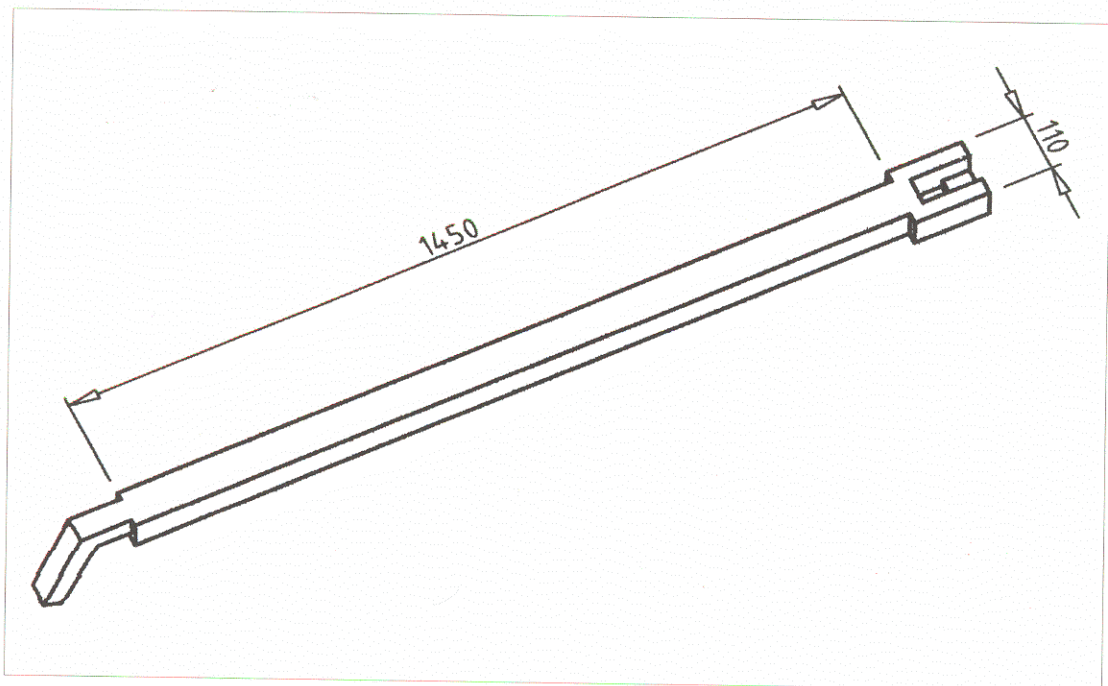
Figure 12
Iron fixation elements
from the foundations
of the Roman bridge.

Figure 13 Dimensions of the fixation element, in mm.

During the investigation of the Seljuk bridge in the early 1990's on behalf of the planned restoration work, divers inspected the Roman foundations upon which the Seljuk piers were built. They discovered long heavy bars of iron, furnished with a square hole at one end and a hook at the other (Fig. 12,13)¹³. Each hook fits into the hole of the next bar. The bars measure 140 cm in length and 7 x 7 cm in thickness and weigh about 55-60 kg. The divers brought three bars to the surface, one of which is almost intact except for the hook which is broken off. They are in excellent condition. The bars apparently served as fixation elements (*Spannanker*) for the stone blocks forming the foundations of the bridge piers (Fig. 14). It was said that the divers saw several of these fixation elements *in situ* in the foundations. Remains of mortar adhering to the surface suggest that the bars were placed in slots cut in the stones and covered with mortar (Fig. 15). A similar fixation method is known from the Roman bridge over the river Tyne in England¹⁴, but the size of the fixation elements of the Roman bridge at Aspendos seems unparalleled.

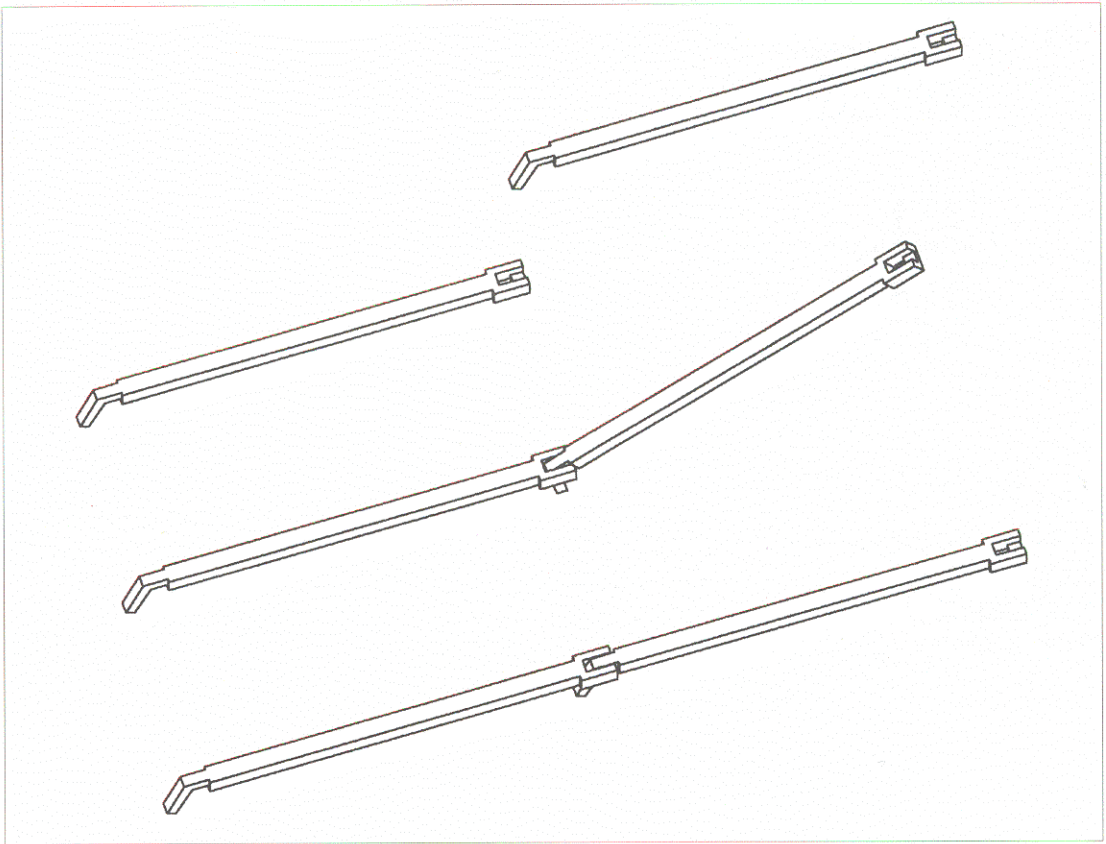
Figure 14 The slanted hook facilitated the positioning of the elements.

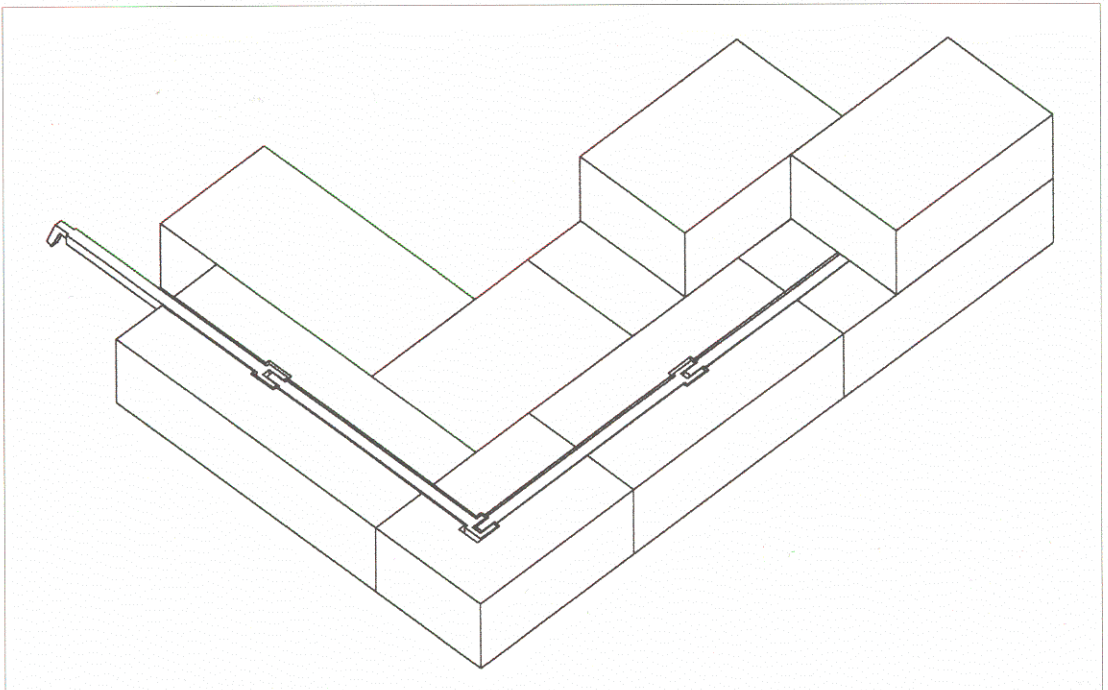
Figure 15 Reconstruction of the fixation elements incorporated in the foundation of the bridge pier.

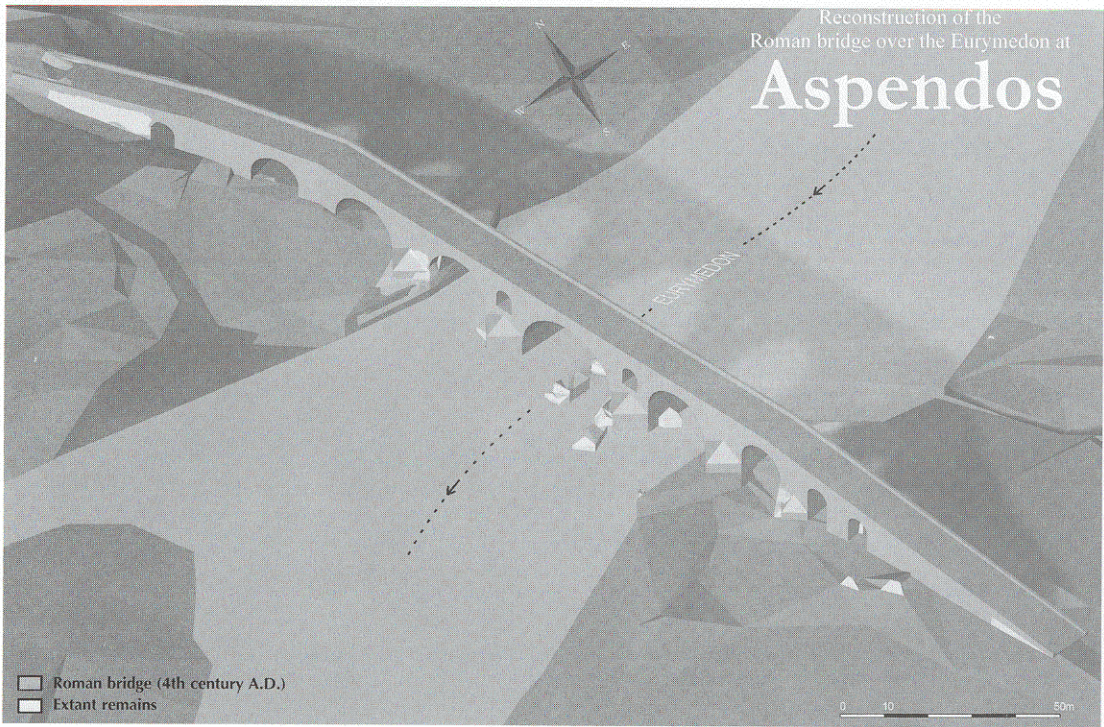
Figure 16 Reconstruction of the Roman bridge (S. Harmeling-M. Stitz).

The sloping of the ramps are of particular interest, as these might provide clues about the original height of the bridge. The slopes were measured with high precision, and they turned out to be remarkably similar: 12.3 percent for the right ramp, and 12.2 percent for the left ramp. Reconstruction by extrapolation of both ramps along a straight line would result in a bridge of gigantic dimensions. Its highest point would have been over 12 m above the present bridge level allowing ships up to 20 m in height to pass. However, such a form of bridge finds no parallel in Roman times¹⁵ and, moreover, the reconstruction could not be made to comply very well with the in situ remains in the river.

Instead of this, a reconstruction with the sloping of the ramps ending in the area of the riverbanks, and with a roadway turned to the horizontal, necessitated a total of 6 arches in the horizontal part of the bridge (Fig. 16). Three smaller arches, one on the right side 5.1 m wide and still incorporated in the extant remains, and two on the left side were added in the sloping parts for the passage of water in conditions of flooding. The river itself, in between the moles on either side, was crossed by means of three arches, the dimensions of which may be deduced from the distance between the moles and the in situ remains of the pier in the river. From this, and from arguments of symmetry, the diameter of the middle arch could be estimated to have been 23.5 m while for the adjoining arches a diameter of 15 m could be accounted for. In the river two massive breakwaters 9.6 m wide had served as support for the arches. It was noted that the moles on the upstream side were, at 8.2 m, longer than the 4.8 m on the downstream side, which seems reasonable enough in view of the direction of the fast flowing water. Such moles were common in Roman times; a technical detail designed to prevent the river undermining the piers erected on the riverbanks. On the left side of the river, the river's strong flow accomplished exactly what these reinforcements should have prevented: the mole partly sagged into the river together with the foundation of the pier and the breakwater, their original position can only to be conjectured today (Fig. 17).

The Roman bridge was about 4.1 m higher than its Seljuk counterpart. It was 9.6 m wide, and had a total length of 260 m. The extended walling in the part of the bridge above the massive piers and breakwaters in the river were presumably equipped with openings for the passage of water in flooding conditions. This can be considered as a standard provision in Roman bridge construction¹⁶.

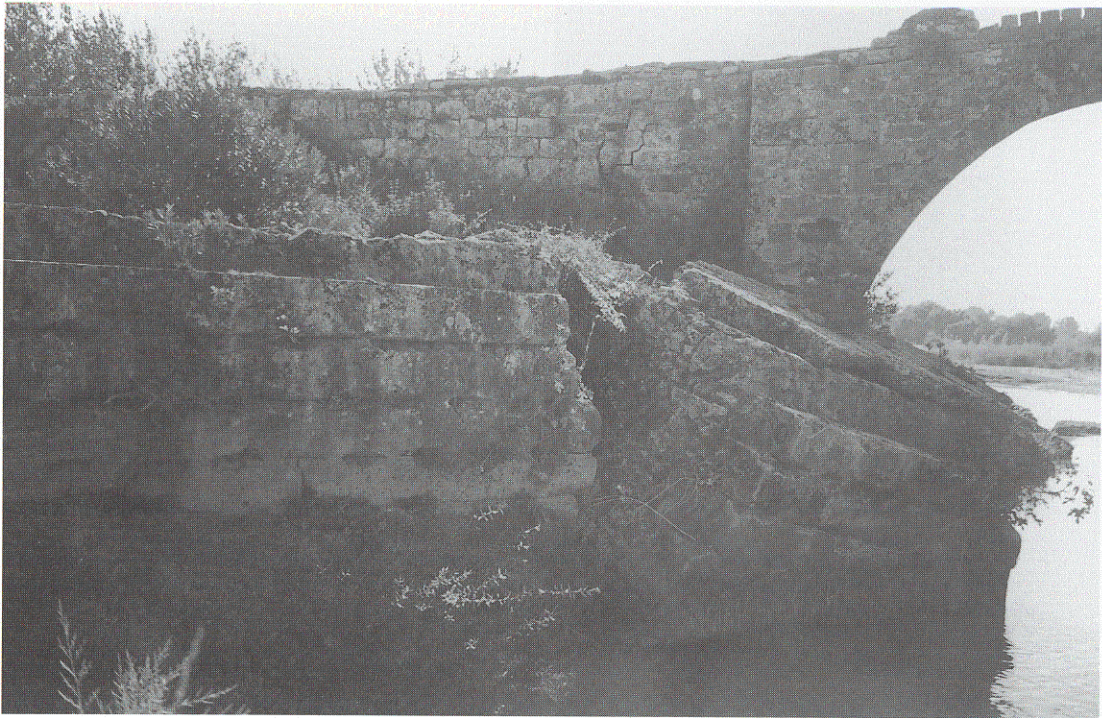
Figure 17 Remnants of the upstream mole of the Roman bridge, on the left side of river.

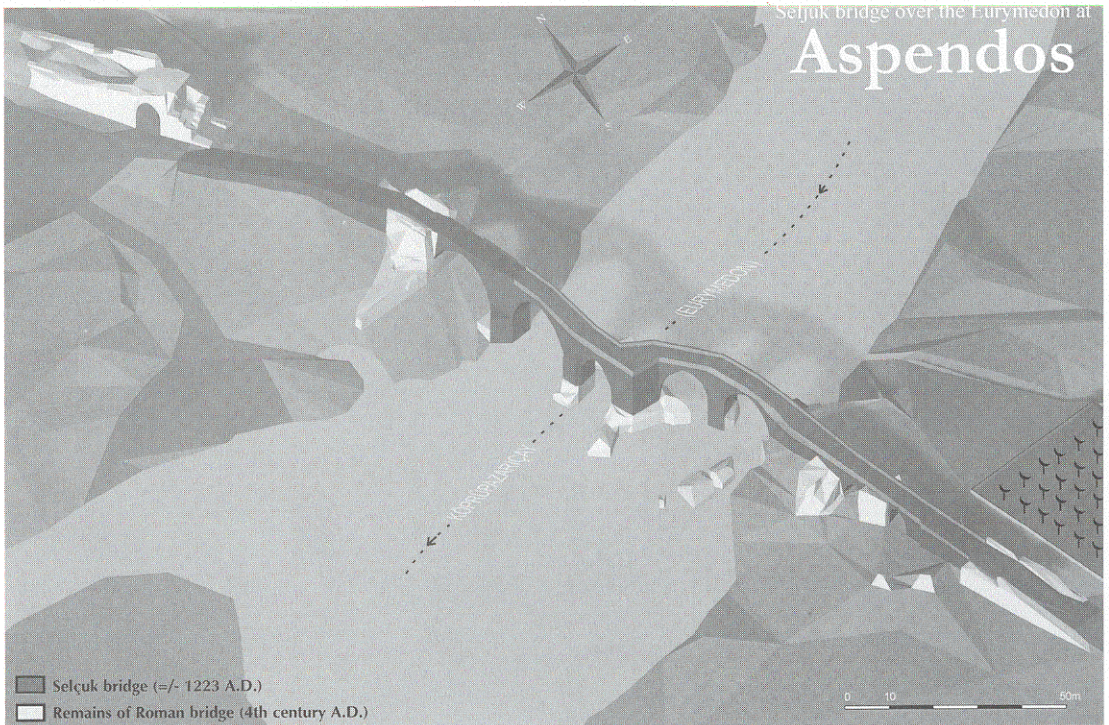
Figure 18
The Seljuk bridge and remains of the Roman bridge, in its present state (S. Harmeling-M. Stitz).

It may have been an earthquake again, perhaps combined with an enormous flood of water, that caused the Roman bridge to collapse, when, we don't know. After the consolidation of Seljuk power in this region early in the 13th century it was decided to renew the river crossing once more. The Seljuks decided the ruins of the Roman bridge were stable enough to be used as foundations for their new bridge, which must have saved them considerable effort. Their design provided for a bridge of lower height, they were probably unaware of how the former bridge had looked like, the Roman ruins blocked the pas-

sage of ships to a city which no longer served as a port of any significance. As in time the river had shifted its bed towards the left side, the Seljuks could safely construct a new ramp on the right bank closer to the river just in front of the Roman breakwater. The left ramp of the Roman bridge could be used as it was. In the river the Roman piers and breakwaters had partly broken up and had fallen apart while large portions of the bridge itself had fallen into the river adding to the material the Seljuks could reuse. They had to build their way across the river in some sort of a hop, skip and jump, building their bridge half as wide as its Roman counterpart with a parallel shift in the middle of the river (Fig. 18). Of course they made use of the materials of the Roman bridge lying about on the riverbanks, thus applying pipe elements of the Aspendos aqueduct once more.

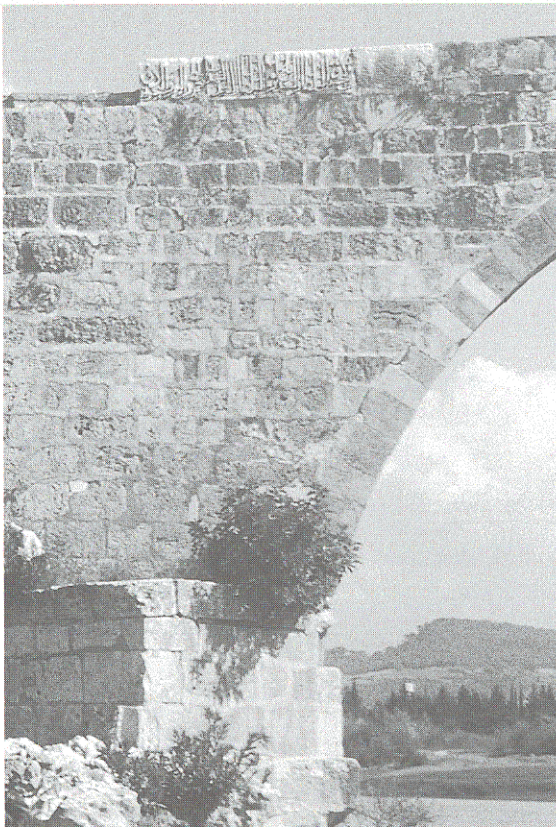
Figure 19
The Parapet with the Seljuk

Figure 20
The Marble slab
with its Seljuk
inscription in the
river bed.

Stone slabs were used for the parapet, of which at least one, many having been toppled over the side in time, turned out to bear an inscription in Greek. The inscription, on the upstream side near the right riverbank, was inserted up side down and must be considered as spolia¹⁷. On the downstream side, above the first pier in the river near the right bank, a Seljuk inscription of excellent quality has been preserved. It consists of three stone slabs alongside each other (Fig. 19). A fourth slab was found lying in the riverbed on the upstream side (Fig. 20). The bridge has been extensively restored between 1997-1998¹⁸, gaining a completely new roadway and a parapet for all its length, the slabs which had been dislodged from their positions were again to be included in the new parapet (Fig. 21,22,23). Originally there were at least five inscription slabs as photographs of the intact parapet made in the seventies show, which regrettably lack sufficient quality to permit decipherment¹⁹. According to S. Fikri Erten, founder of the Antalya Museum, the original inscription was composed of 6 separate stone slabs, of these stones slabs, the one carrying the date of construction and the name of the Sultan who commissioned this building were not found²⁰. The present parts however mention the names of Sultan Keyhüsrev (1192-1196 and 1205-1211), and of Sultan Kılıç Aslan (1155-1192) who was Keyhüsrev's father, suggesting that Sultan Alaeddin Keykubat (1220-1232), the son of Keyhüsrev, may be considered as the builder of the present bridge, probably shortly after he conquered Alanya in 1221.

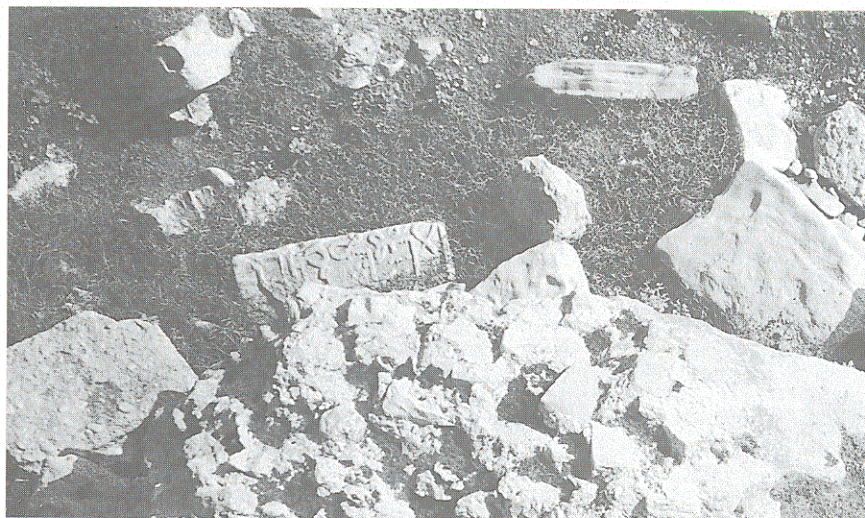
Figure 21
Two stone slabs
with the inscription
to be replaced in
the parapet
(H. Franssen).

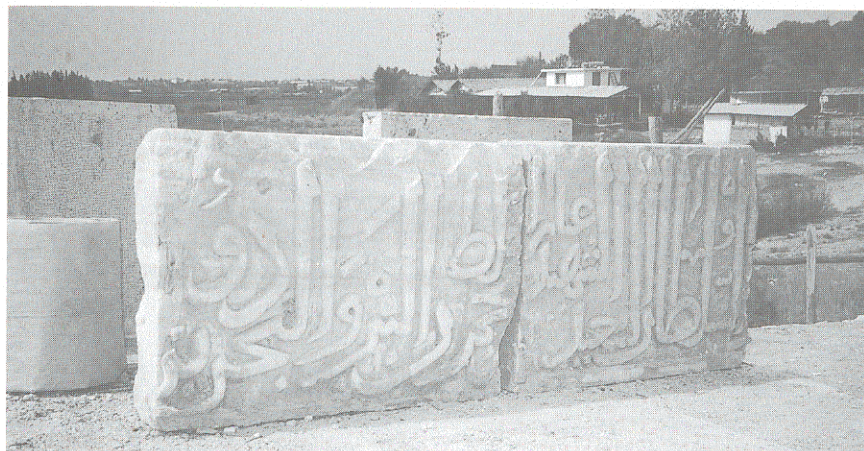
Figure 22
The Construction
of new parapet
with the Seljuk
inscription
(H. Franssen).

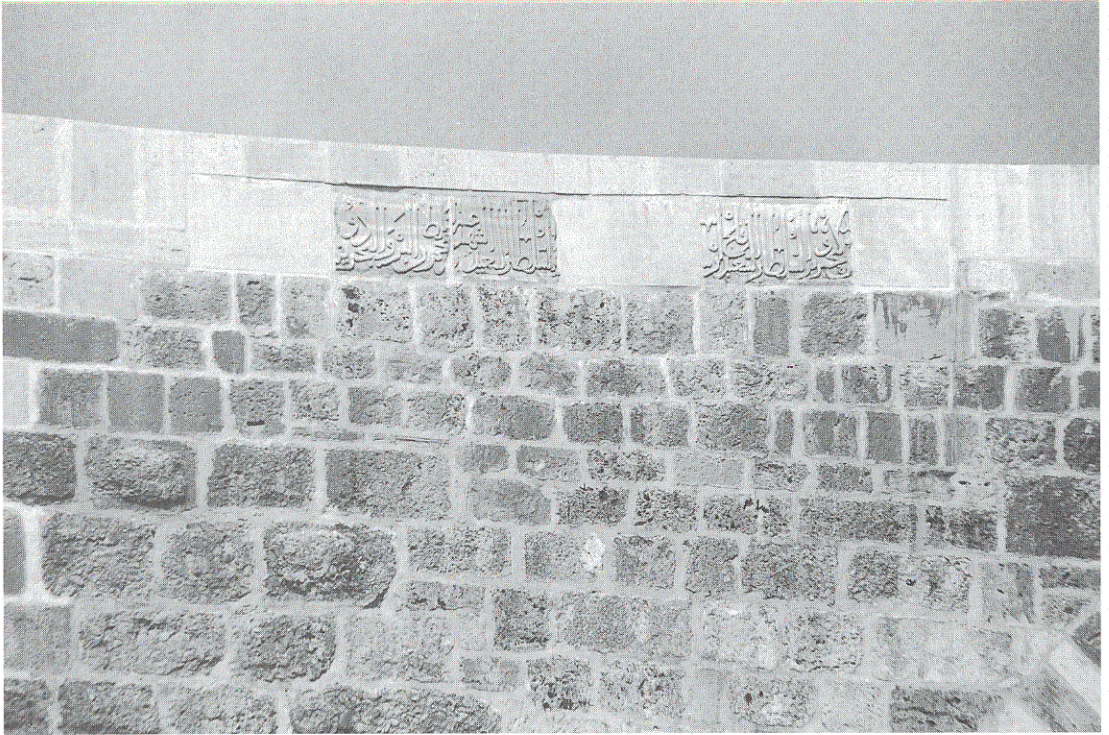
Figure 23 The Parapet with inscription, in its present state.
